### Project Summary

- 367 linear feet of 12-inch ACP sewerline replaced with new 15-inch PVC
- From initial report of blockage to completion of construction: 14 days
- Construction period: 10 days
- No overflows
- No change orders
- Side benefit: odor at curbside & Park drainage – gone?

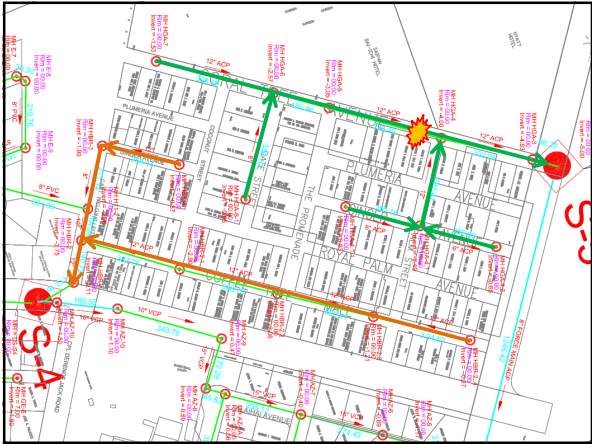
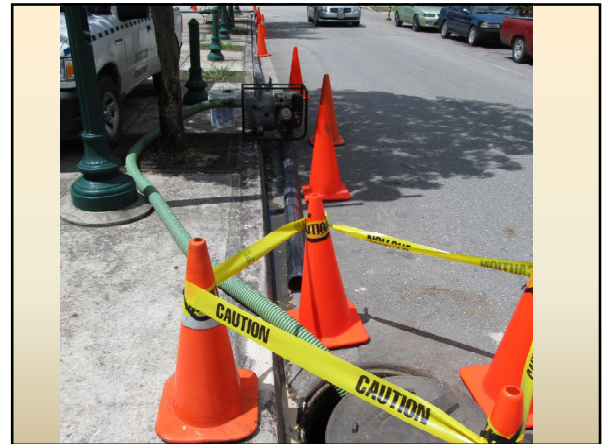
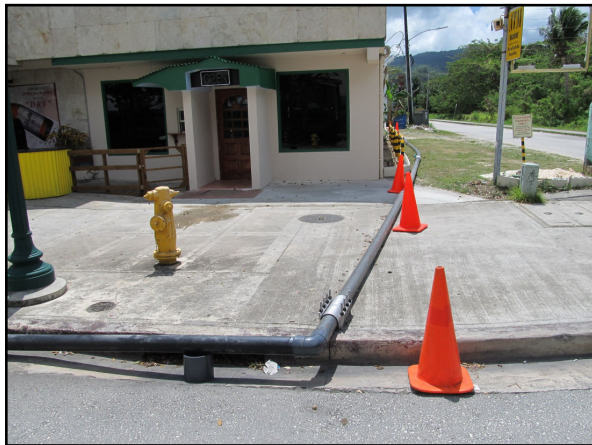
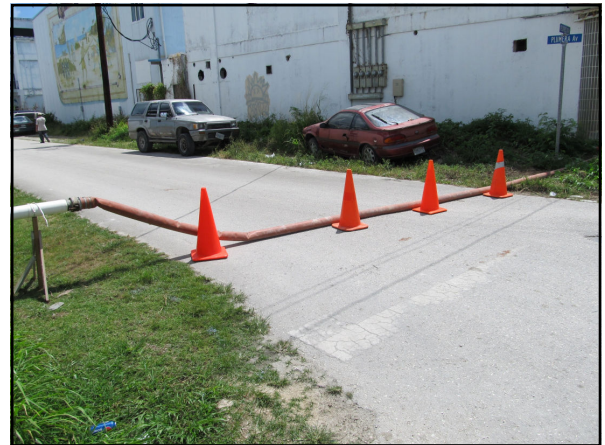
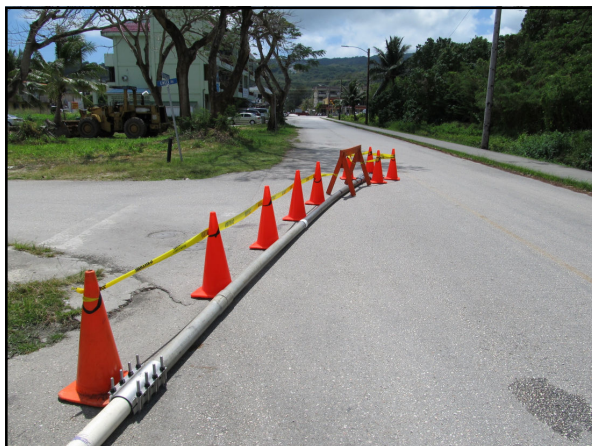
First Step:

- Divert the sewage around the blockage  
— PREVENT AN OVERFLOW!!!!

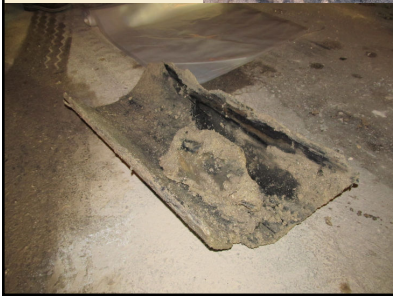
How would you repair a collapsed asbestos cement pipe?

- Hydrogen Sulfide Attack

- Replace entire section of pipe

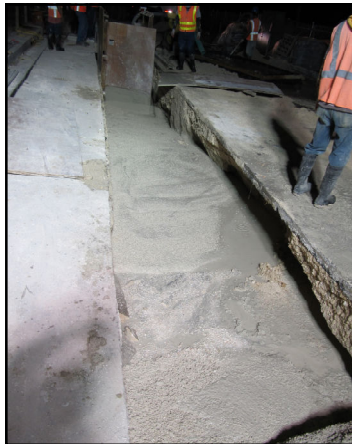
Fill up to final  
12 inches with  
~150-250 psi  
flowable fill

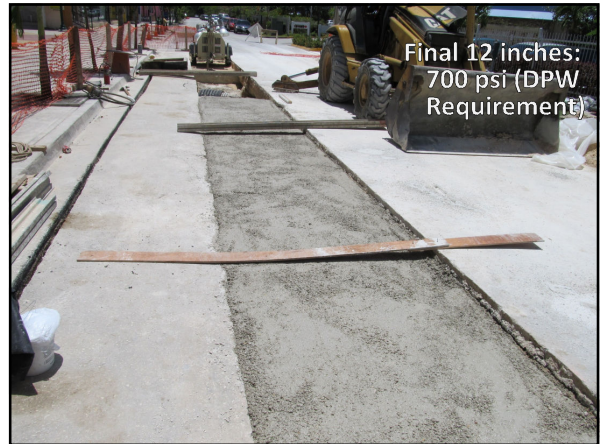
Final 12 inches:  
700 psi (DPW  
Requirement)

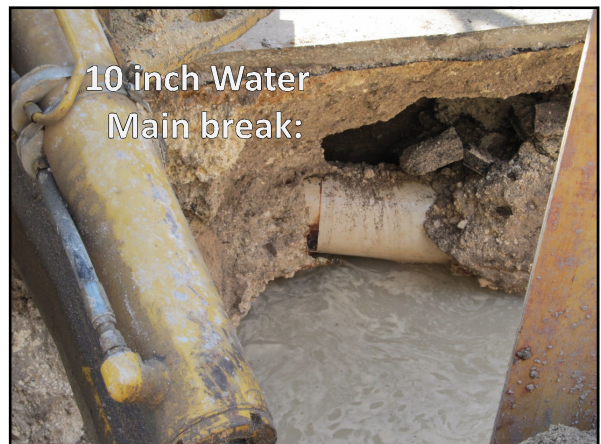
10 inch Water  
Main break:
